Army Corrosion Summit

Army Aviation Corrosion Engineering Case Studies

Dan Groner

Date: 10 February 2010

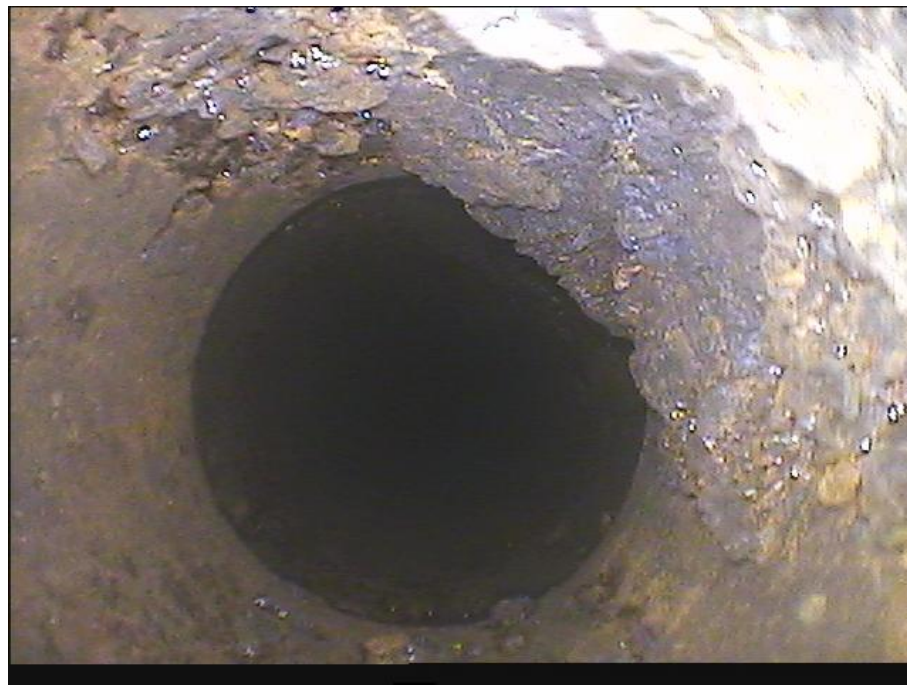
- A Category I Quality Deficiency Report (QDR) investigation of the FWD Fast Rope Insertion Extraction (FRIES)/External Rescue Hoist support rod (P/N LEX-1583-05), consisting of microscopic, ultrasound, and metallurgic examination revealed severe corrosion of the inside surface of the rod. Subsequent investigation of additional ship sets revealed several support rods within the FWD FRIES/External Rescue Hoist truss assembly exhibiting similar corrosion.

Interior view of severely corroded Support Rod

- **Resolution**
- ASAM H-47-09-ASAM-04 is issued
- Requires inspection and grading of the corrosion severity
- Thoroughly dry the rod and treat interior with MIL-C-16173, Grade 3
- Restrict usage of the FRIES station based on corrosion severity

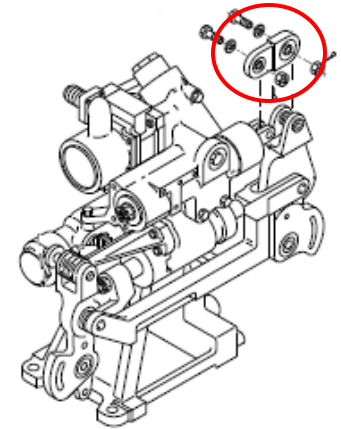
- **The Investigation**
- Drawing review – the link was not to print
 - 7075-T651 versus 7075-T73
 - Press fit versus adhesive and staked
- Structural Analysis
- Failure Analysis
- Risk Analysis
